DEFECT REPORT PER IBC STANDARDS

# Site Check

24 Rogers Ave, Brooklyn, NY 11216

Photo-based site monitoring · 26.09.2025 – 04.08.2026 · 37 photos · 15 areas

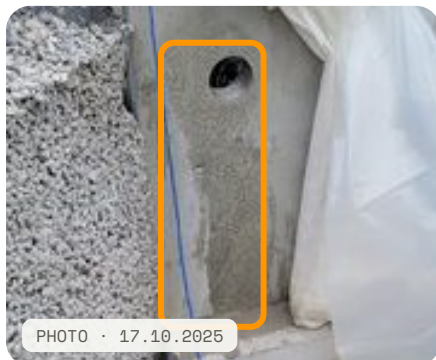
## M-02 Evaluate concrete surface crazing

**Extensive map cracking (crazing) is visible on the concrete wall surface around the penetration area.**

The vertical cast concrete wall exhibits a pattern of fine surface map-cracking (crazing) adjacent to the circular core hole. While usually superficial, surface cracking in exterior below-grade or retaining structures should be evaluated to ensure micro-cracks do not affect long-term freeze-thaw durability or permit moisture ingress before backfilling occurs.

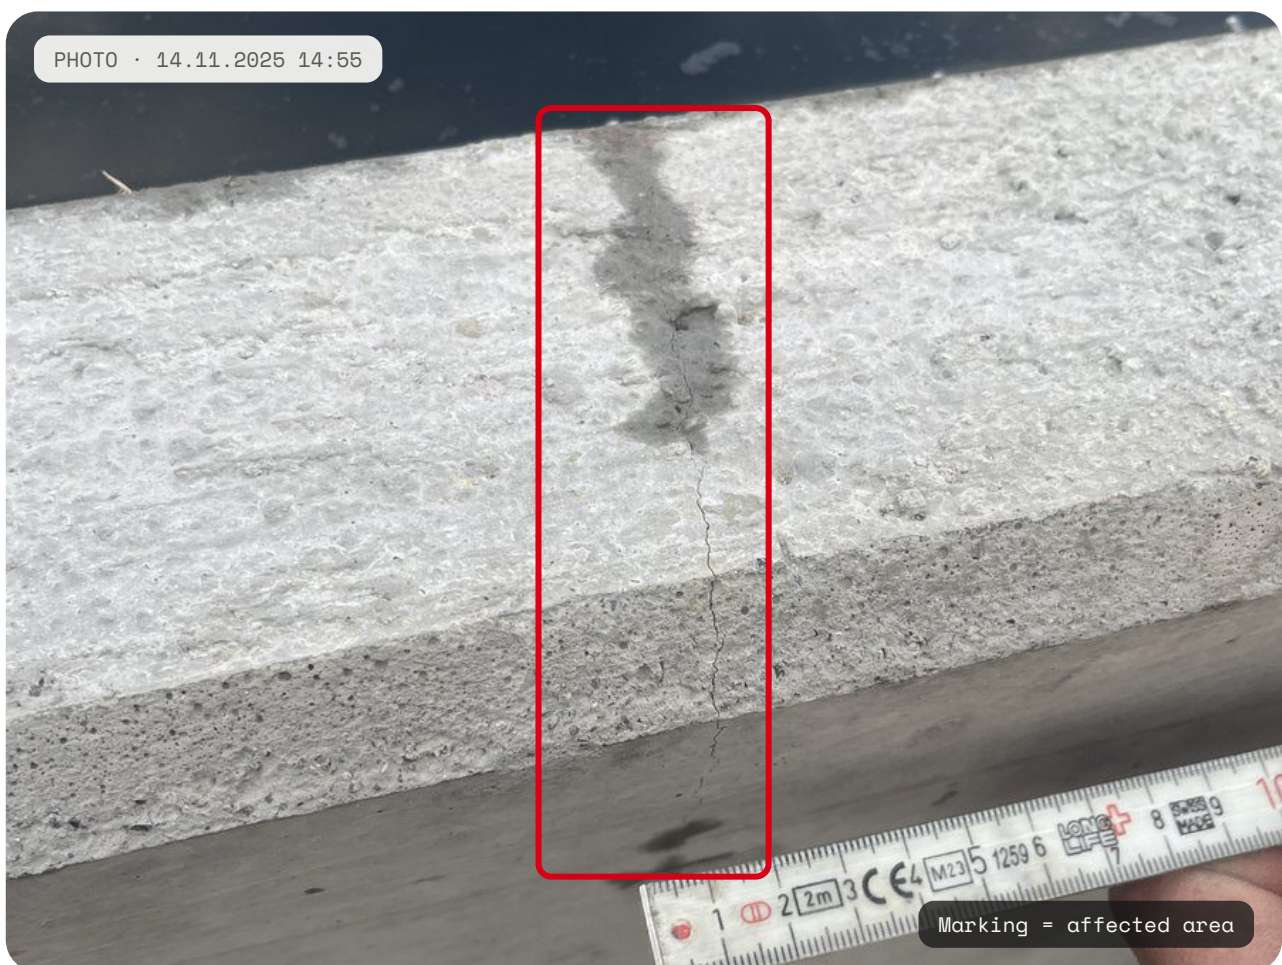
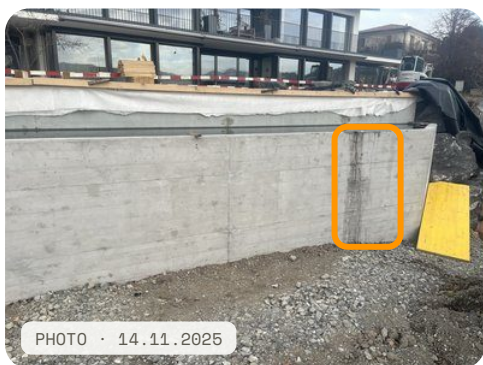
## M-04 Evaluate and seal continuous vertical concrete crack

A fine vertical crack extends across the top horizontal edge and down the vertical face of the concrete retaining wall coping. Dark dampness along the crack indicates active moisture ingress. In exterior exposure, water penetration through cracks compromises durability by inducing freeze-thaw degradation and accelerating internal reinforcement corrosion. The crack width should be measured and evaluated by the structural engineer against ACI 224R limits, and an appropriate repair methodology (such as epoxy injection or penetrating elastomeric sealer) must be performed per ACI 546R prior to subsequent trade work.

Active moisture along a structural concrete crack creates an immediate pathway for freeze-thaw damage and rebar corrosion. Sealing must occur before backfilling or exposure to severe weather, classifying this as major / stop\_and\_fix.

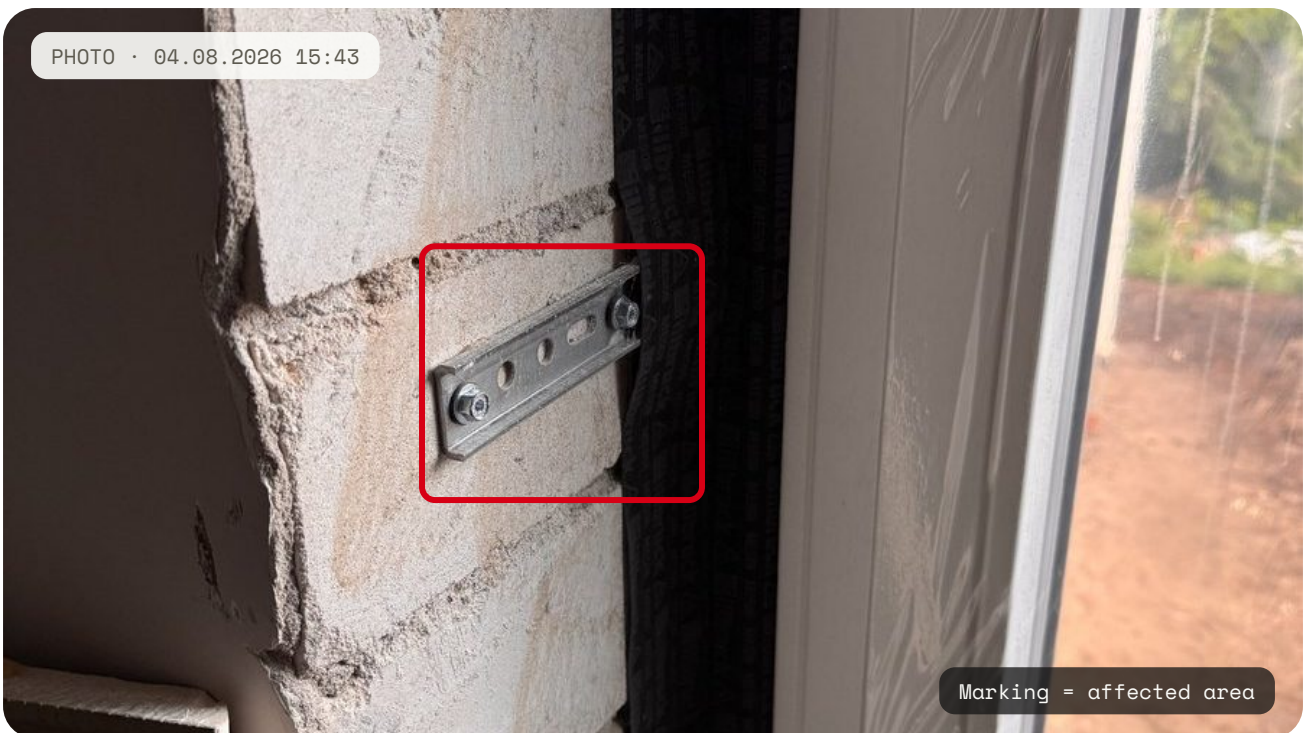
## M-08 Adhere window sealing membrane properly at anchor attachment point

The illbruck ME508 sealing tape is designed to create a continuous, airtight, and vapor-retarding seal between the window frame and the rough opening masonry. The tape is hanging loose, and a metal mounting anchor was fastened directly over it. To ensure a functional seal and prevent air infiltration and moisture damage, the anchor must be temporarily loosened, the masonry substrate properly primed and prepared, and the tape fully adhered before re-securing the anchor.

Classified as quality / major / stop\_and\_fix because clamping the membrane beneath the anchor prevents establishing a continuous airtight seal, which must be corrected before plastering conceals the connection.

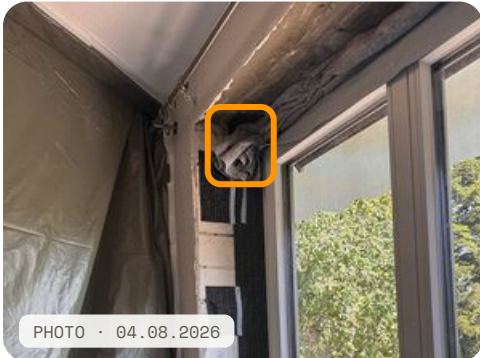
#### M-09 Secure and seal window head thermal insulation

**Thermal insulation at the window head is loose and lacks a continuous air sealing membrane.**

Insulation material stuffed into the gap between the top of the window frame and the concrete head lintel is exposed and hanging loose without a sealed air barrier membrane. The insulation must be neatly compressed and fully covered with an airtight flashing tape tied into the lintel, maintaining continuity with the jamb seals.

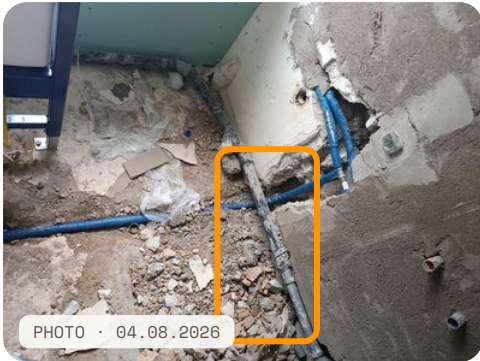
## M-15 Provide Proper Bedding for Drainage Pipe

**The sanitary drainage pipe is resting directly on uneven rubble and lacks continuous support.**

The black sanitary drainage pipe is currently resting on uneven construction rubble and dirt. Before the subfloor or screed is poured, the pipe must be provided with proper, uniform bedding (such as sand or fine gravel) to ensure continuous support. Pouring concrete directly over the pipe in its current state could cause point loading, sagging, or cracking, leading to drainage failures.

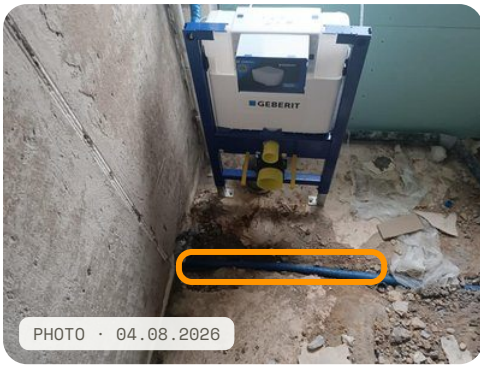
## M-17 Protect Water Line Before Backfilling

**The blue water supply line is lying directly on sharp concrete rubble in the open trench.**

The blue water line is currently resting on sharp concrete debris within the floor trench. Before the trench is backfilled or concrete is poured, the area beneath and around the pipe must be cleared of sharp rubble. The pipe should be provided with proper sand bedding or a protective sleeve to prevent mechanical damage and future leaks under the slab.

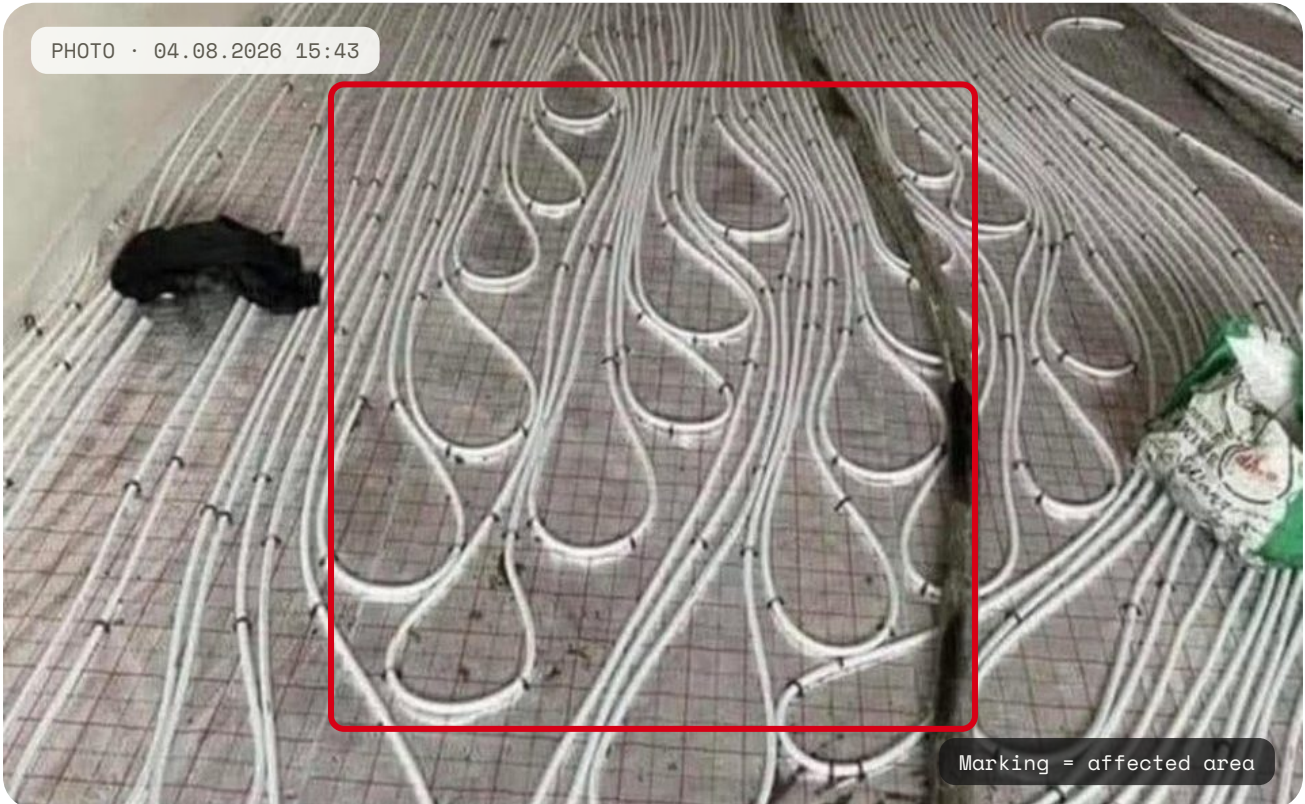
**M-21**

## Non-standard hydronic radiant tubing layout

The hydronic tubing has been laid out in a decorative flame/teardrop pattern rather than standard parallel serpentine or counter-flow spiral loops. This non-conforming arrangement results in highly variable pipe spacing across the floor, leading to localized hot and cold spots as well as hydraulic balancing complications due to irregular bend radii and loop lengths. Tubing must be re-routed according to engineered mechanical design drawings before screed is poured.

Re-laying tubing is critical prior to concrete screed encasement; failure to correct this before pouring leads to permanent performance failure.

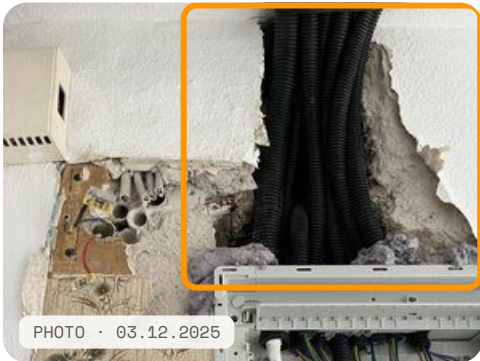
## M-23 Seal wall cavity perimeter around subpanel enclosure

**Large openings and exposed insulation around the recessed subpanel require firestopping and patching.**

The installation of the recessed distribution panel left substantial gaps in the masonry/drywall wall cavity, currently stuffed loosely with mineral wool. Coordinate with wall-finishing trades to install approved firestop sealing around conduit entries and patch the wall opening flush to the panel frame.

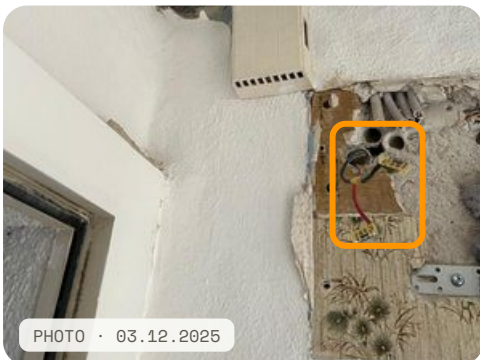
## M-24 Enclose exposed wire splices in junction box

**Exposed wire splices above the door frame require an approved junction box before wall patching.**

Conductors above the door frame are joined with push-in wire connectors directly in the open wall cavity. According to NEC requirements, all splices must be housed inside an accessible, approved junction box with a cover to contain sparks and protect connections from damage before plaster repairs take place.

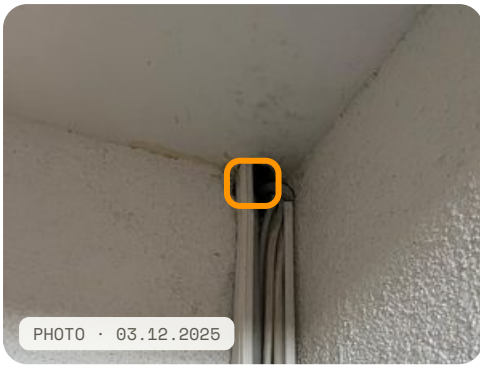
### M-25 Seal ceiling cable penetration above surface raceway

**The annular space around the cables at the ceiling penetration above the vertical raceway is unsealed.**

An open gap exists where low-voltage/power cabling enters the ceiling cavity above the surface raceway. Prior to final raceway cover attachment, the penetration must be filled with approved firestop or draftstop material to prevent smoke and draft transmission through the ceiling assembly.

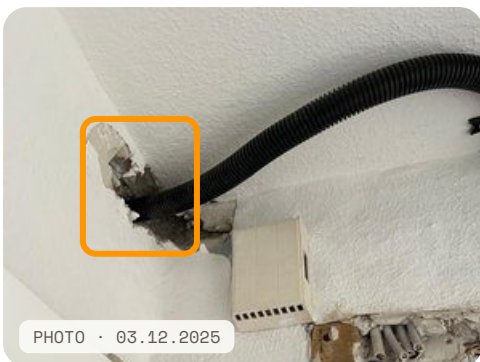
### M-26 Seal wall penetration around conduit above door frame

**Rough plaster penetration for the flexible conduit requires sealing before wall patching.**

A black corrugated flexible conduit passes through a roughly broken opening in the wall-ceiling junction. Before the wall is patched and painted, properly seal the void surrounding the conduit with approved fireblocking or draftstopping compound.

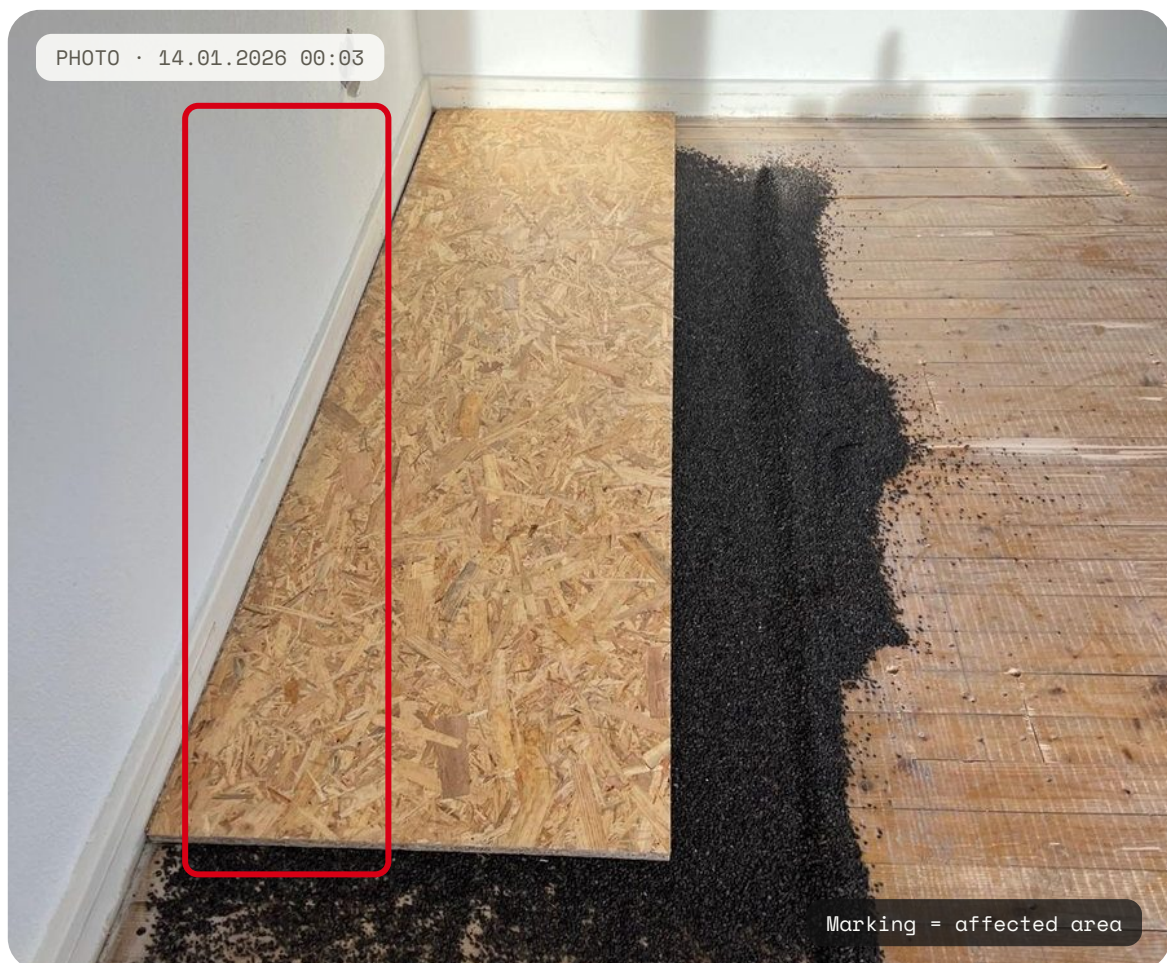
## M-36 Missing Perimeter Isolation Strip for Floating Subfloor

The OSB subfloor panel is resting directly against the adjacent plaster wall without a resilient edge isolation strip. Floating subfloor assemblies require continuous perimeter isolation to prevent acoustic bridging into the building structure and to allow lateral movement during humidity fluctuations. Panels must be pulled back and fitted with edge isolation strips before proceeding with panel layout.

Categorized as quality with major severity and stop\_and\_fix time criticality because direct contact with walls creates acoustic flanking bridges and prevents necessary thermal/hygrometric expansion of the wood panels.

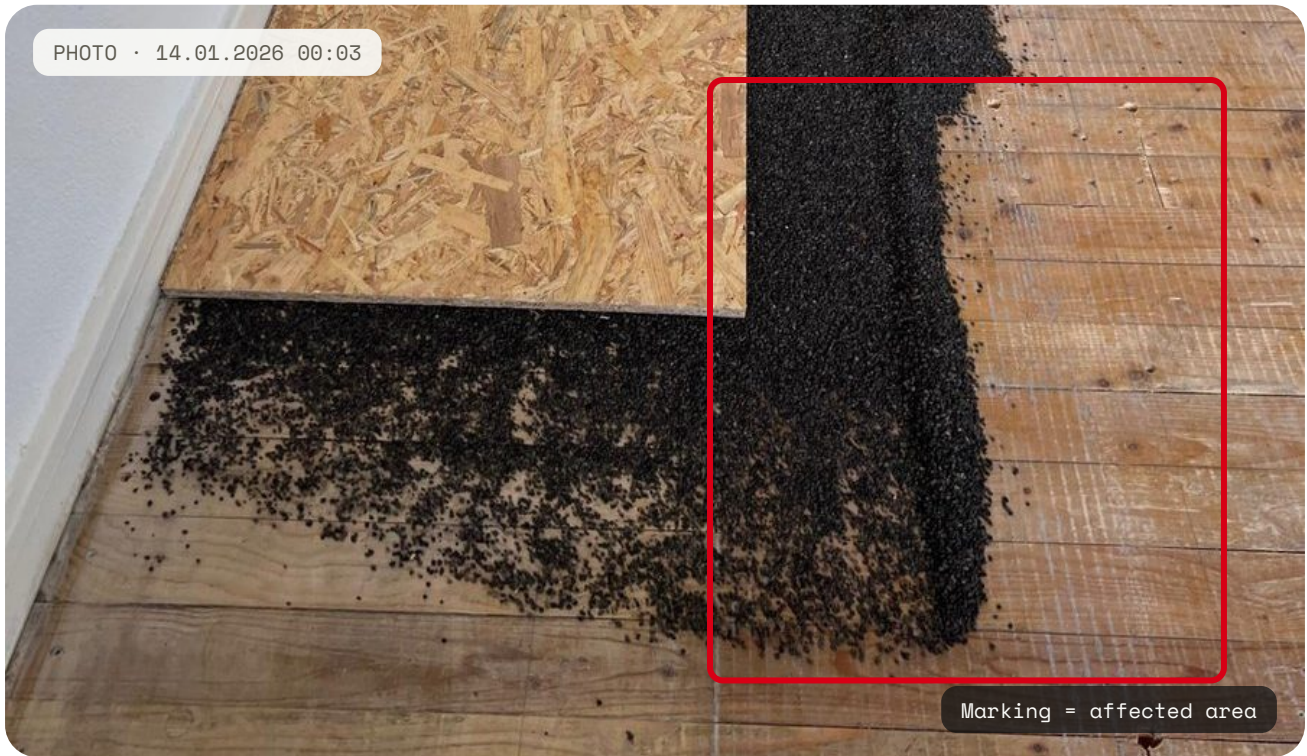
M-37

## Missing Trickle Protection Membrane Beneath Dry Leveling Fill

Granular leveling fill is placed directly over existing wooden floorboards with visible gap spacings. Over time, vibration and foot traffic will cause the fill material to migrate down through the gaps, resulting in volume loss, hollow voids, and eventual sagging of the OSB subfloor. A trickle protection membrane must be installed across the entire plank subfloor before pouring and leveling additional aggregate.

Categorized as quality with major severity and stop\_and\_fix time criticality because loose granules will trickle through floorboard gaps, causing structural settling and unevenness of the floating subfloor system.

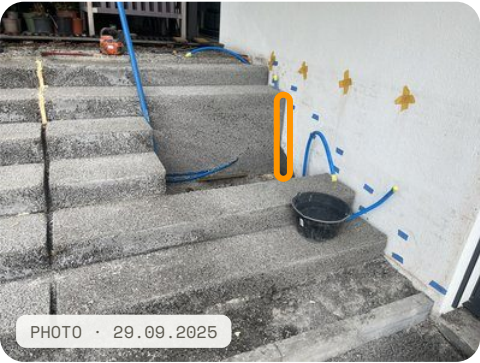
## M-43 Ensure weather-tight sealing at step-to-stucco wall intersection

Verify flashing and waterproofing details where precast steps abut the stucco wall.

Precast concrete step blocks are positioned directly against the finished exterior stucco facade. Verify that expansion joint filler, flashing, or continuous exterior sealant is installed along this joint to prevent water entry.
